Community Science Stream Health Monitoring Programme

Results Summary For Kaipātiki Project

ENVIRONMENTAL IMPACT ASSESSMENTS CLIENT REPORT KP 2019-1
SEPTEMBER 2019

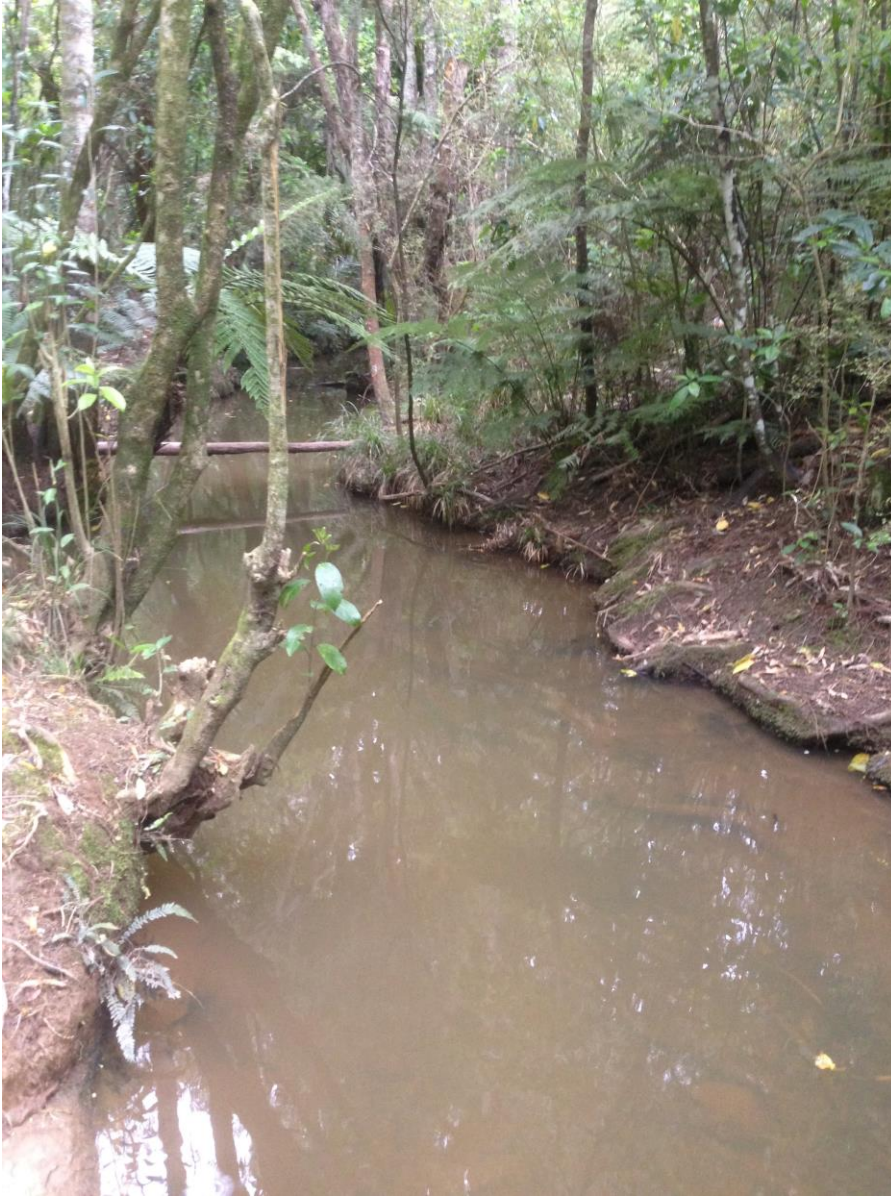
Photo 1: Oruamo U/S Monitoring Site

The Oruamo Creek upstream site is a 3rd order stream that has a catchment area of 0.85km² at the Windy Ridge School stream care monitoring site. The stream falls within the Eskdale Scenic Reserve and is surrounded by native broadleaf/podocarp forest. The upper reaches of the eastern tributaries are devoid of any stormwater inputs while the most northeastern tributary has one stormwater input at the headwaters. The total impervious catchment cover at the Windy Ridge School stream care monitoring site is approximately 8%. This low level of imperviousness is

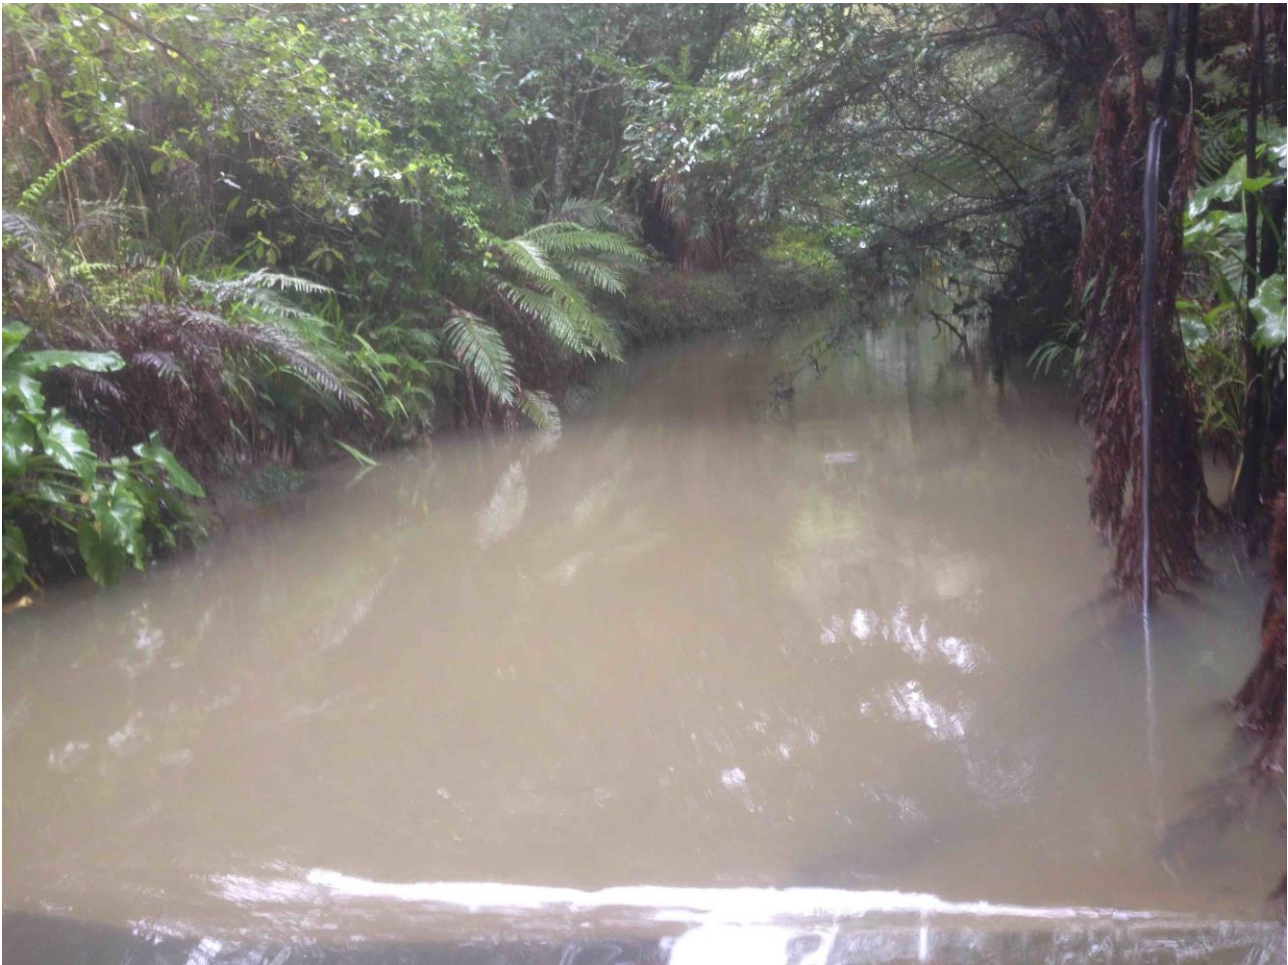
Photo 2: Oruamo D/S Monitoring Site

The Oruamo Creek downstream site is a 4th order stream that has a catchment area of 4.77km² adjacent to the Kaipātiki Project Environment Centre. The site has an Auckland Council hydrology station that measures stream discharge and water temperature every 5 minutes which is exported to the Auckland Council Environmental Data Portal from which data can be extracted.

The stream falls within the Eskdale Scenic Reserve and is surrounded by native broadleaf/podocarp forest. The total impervious catchment cover at monitoring site is approximately 28.4%. This level of imperviousness is likely to result in some adverse effect on stream ecosystem health and as such represents an impact site of moderate severity for this study. The creek catchment is defined by Stanley Road to the north, Glenfield Rd to the east, Mokoia Rd and Waipa St to the South and Birkdale Rd to the west.

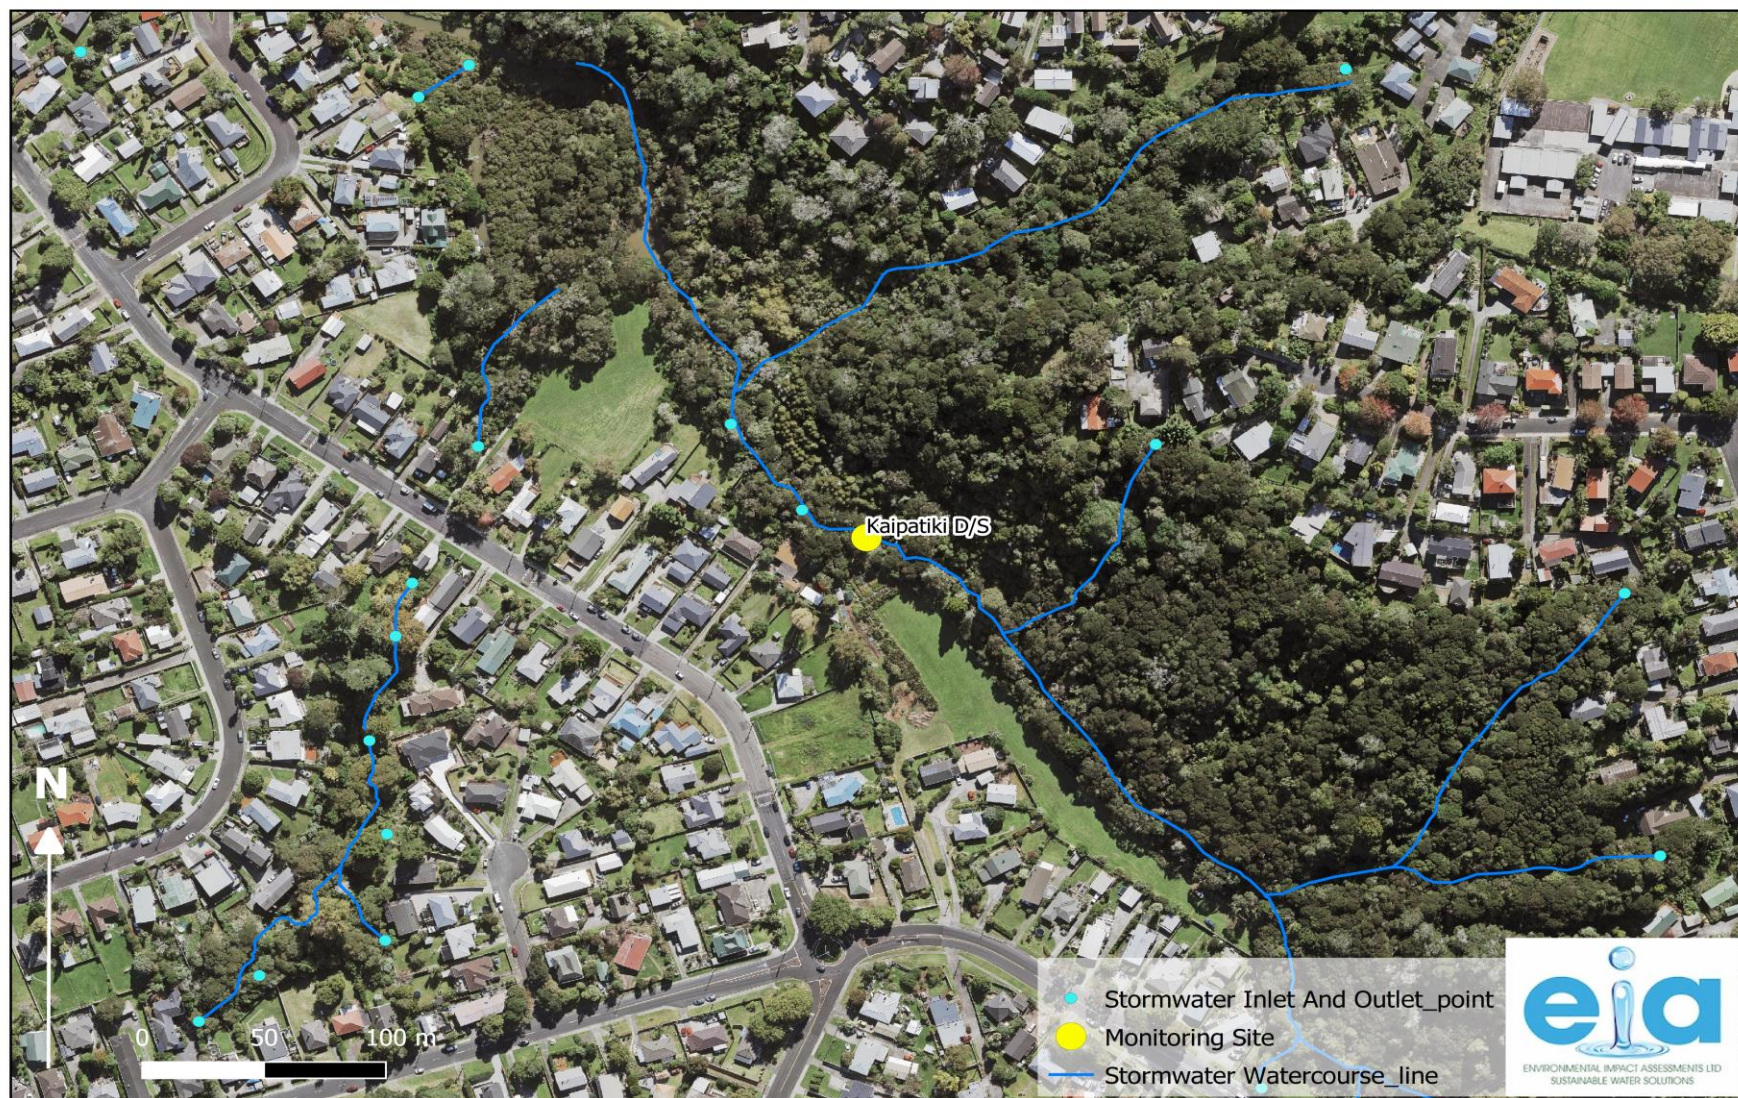
Map 2: Oruamo D/S Catchment

The stream does show some degradation where MCI scores decline markedly compared to the upstream site (Eskdale Lower mean SBMCI 79, max SBMCI 87) reflective of severe organic enrichment. This concurs with our own monitoring with a composite SBMCI score of 85, The stream has a high degree of endemism with no exotic fish or invertebrates previously captured. A recent discovery of kakahi in the lower reaches of the stream is an important finding as this species of bivalve is very rare in the Auckland Region (Henderson pers comm.)

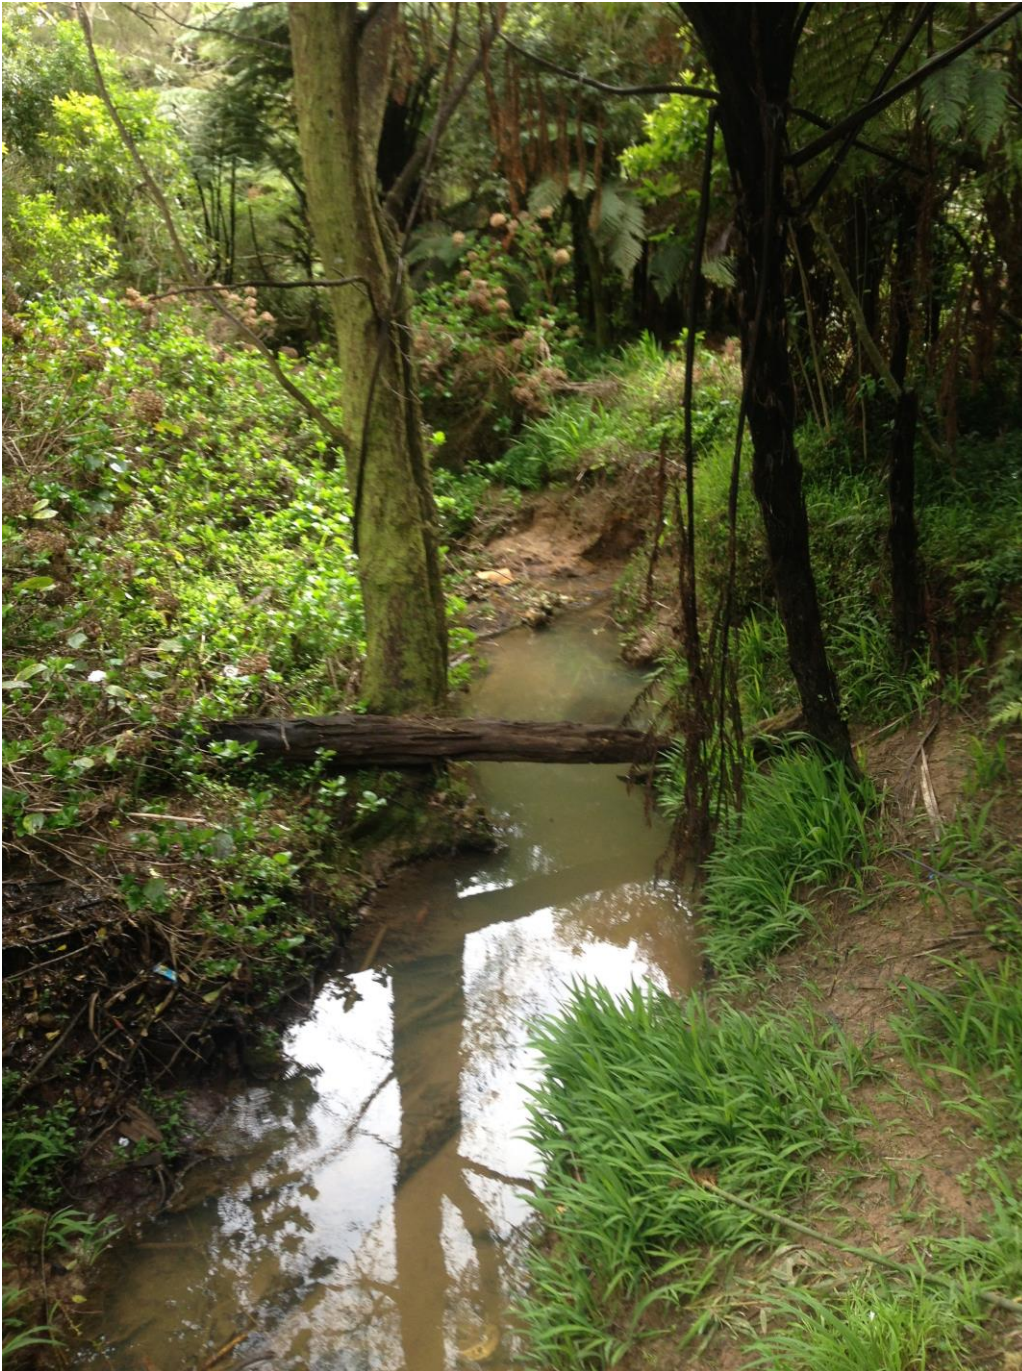
Photo 3: Kahika Creek Monitoring Site

The Kahika Creek is a 2nd order tributary that has a catchment area of 2.0 km² at the Birkdale Intermediate School stream care monitoring site. The stream falls within an urban area bounded by Rangatira Rd to the south and west and Birkdale Rd to the east. The riparian margin compromises some native broadleaf/podocarp trees interspersed with an equal proportion of exotic trees and pest plant species. The stream has many stormwater inputs and the catchment has a total

imperviousness of approximately 33 %. This high level of imperviousness is likely to result in relatively poor ecosystem health owing to the highly altered hydrology created by stormwater inputs from impervious land cover. As such this site represents a highly impacted site for this study.

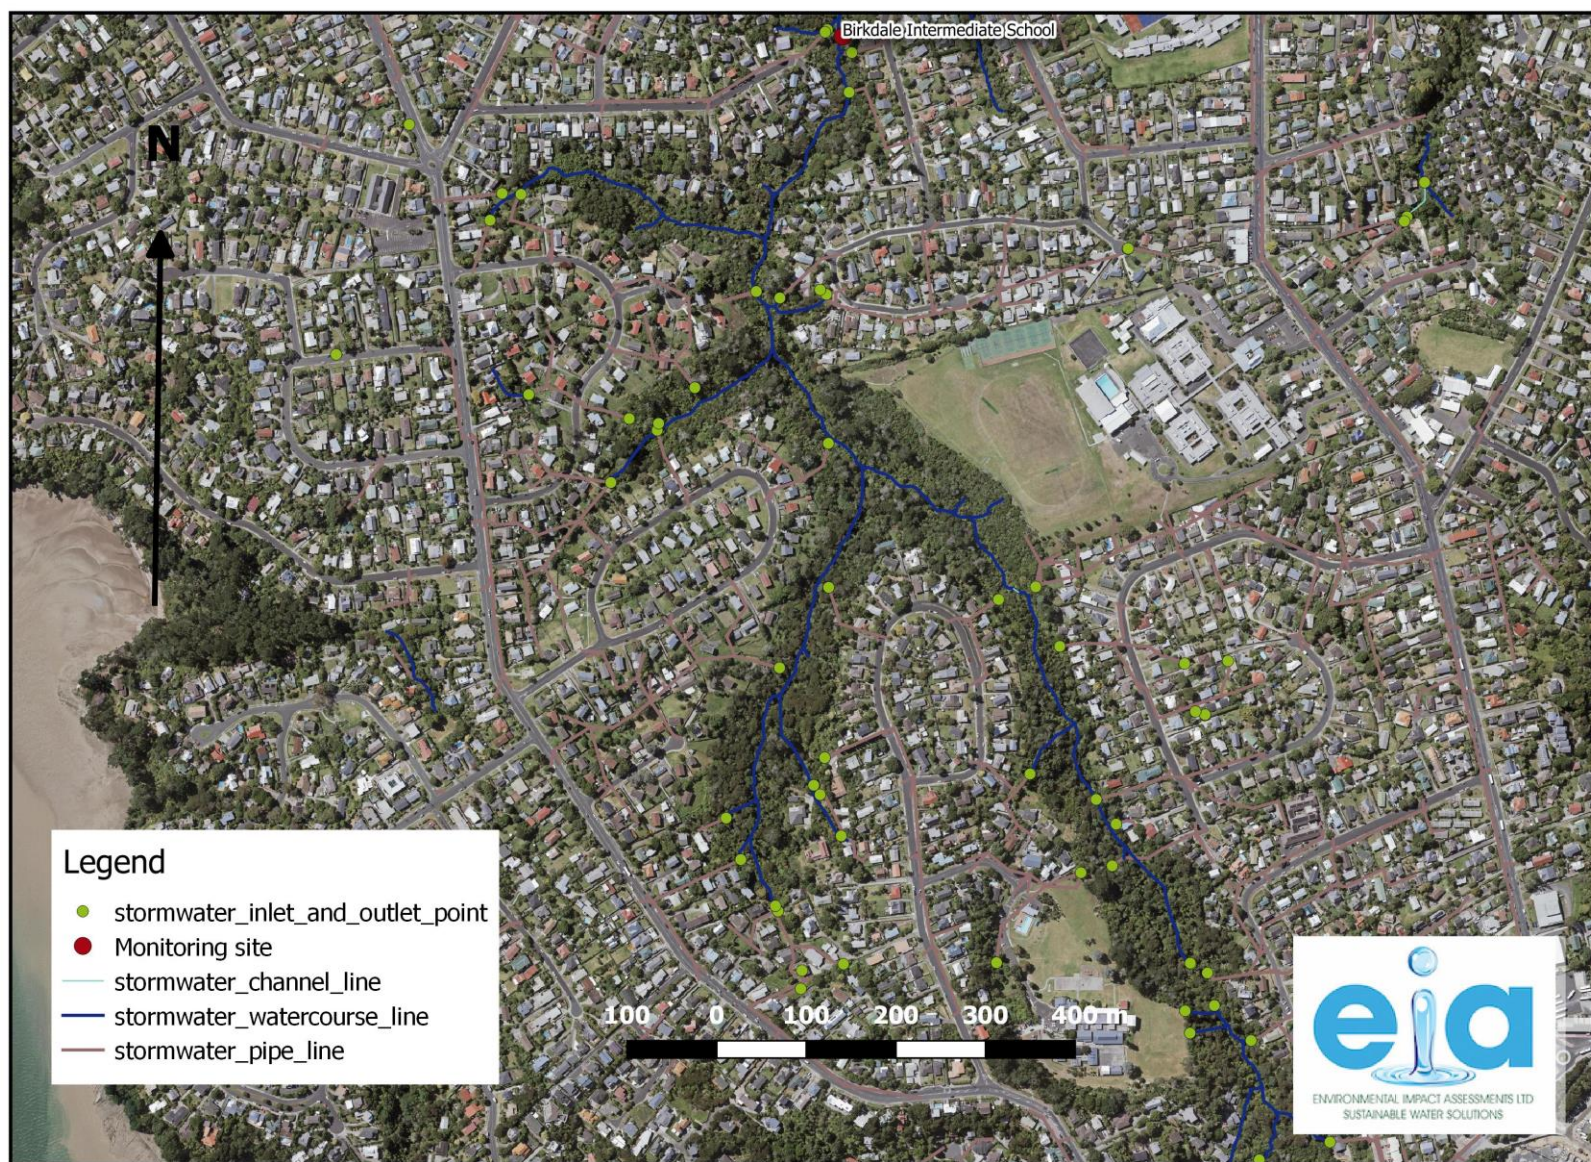
Map 3: Kahika Creek Catchment

Until recently the New Zealand Freshwater Fish Database and the Wai Care Database revealed no biological data for this creek. However repeat field surveys undertaken since October 30 2017 revealed that the creek contains a healthy population of longfin eels, **koura** and banded kokopu. Inanga are also present further downstream where tidal influences are present. Invertebrate monitoring since 2017 has shown the presence of beetles (*Rhantus* and *Lancetes* spp), Damselflies and dragon flies (*Xanthocnemis* and *Antipodochlora* spp), free swimming mayflies (*Zephlebia* spp), oligochaete worms and caddisflies (*Orthopsyche*, *Polyplectropus* and *Triplectedes* spp.). The stream has a SBMCI value of 103 indicative of mild pollution. A map of the Kahika Creek is provided overleaf.

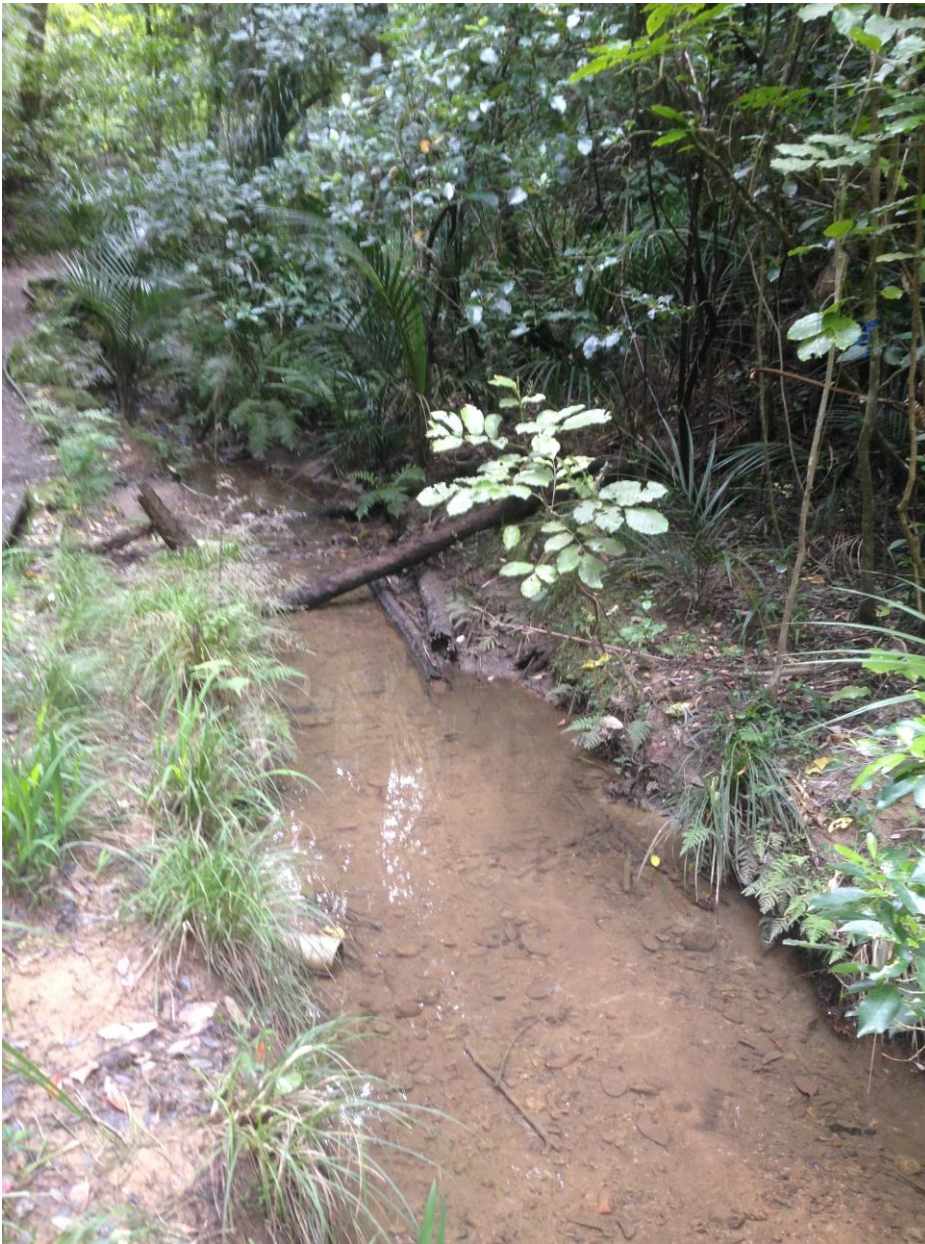
Photo 4: Waimanawa Creek Monitoring Site

The Waimanawa Creek is a 2nd order tributary that has a catchment area of 1.43 km² at the Birkenhead Primary School stream care monitoring site. The stream falls within a scenic reserve (Le Roy's Bush) and residential housing bounded by Onewa Rd to the north and Hinemoa St to the south. The creek discharges to sea at little shoal bay. The riparian margin compromises native broadleaf/podocarp trees with an understory of native grasses and ferns. The creek has many stormwater inputs and the catchment has a total imperviousness of approximately 30 % at the Birkenhead Primary School stream care monitoring site. This high level of imperviousness is likely to result in relatively poor ecosystem health owing to the highly altered hydrology created by

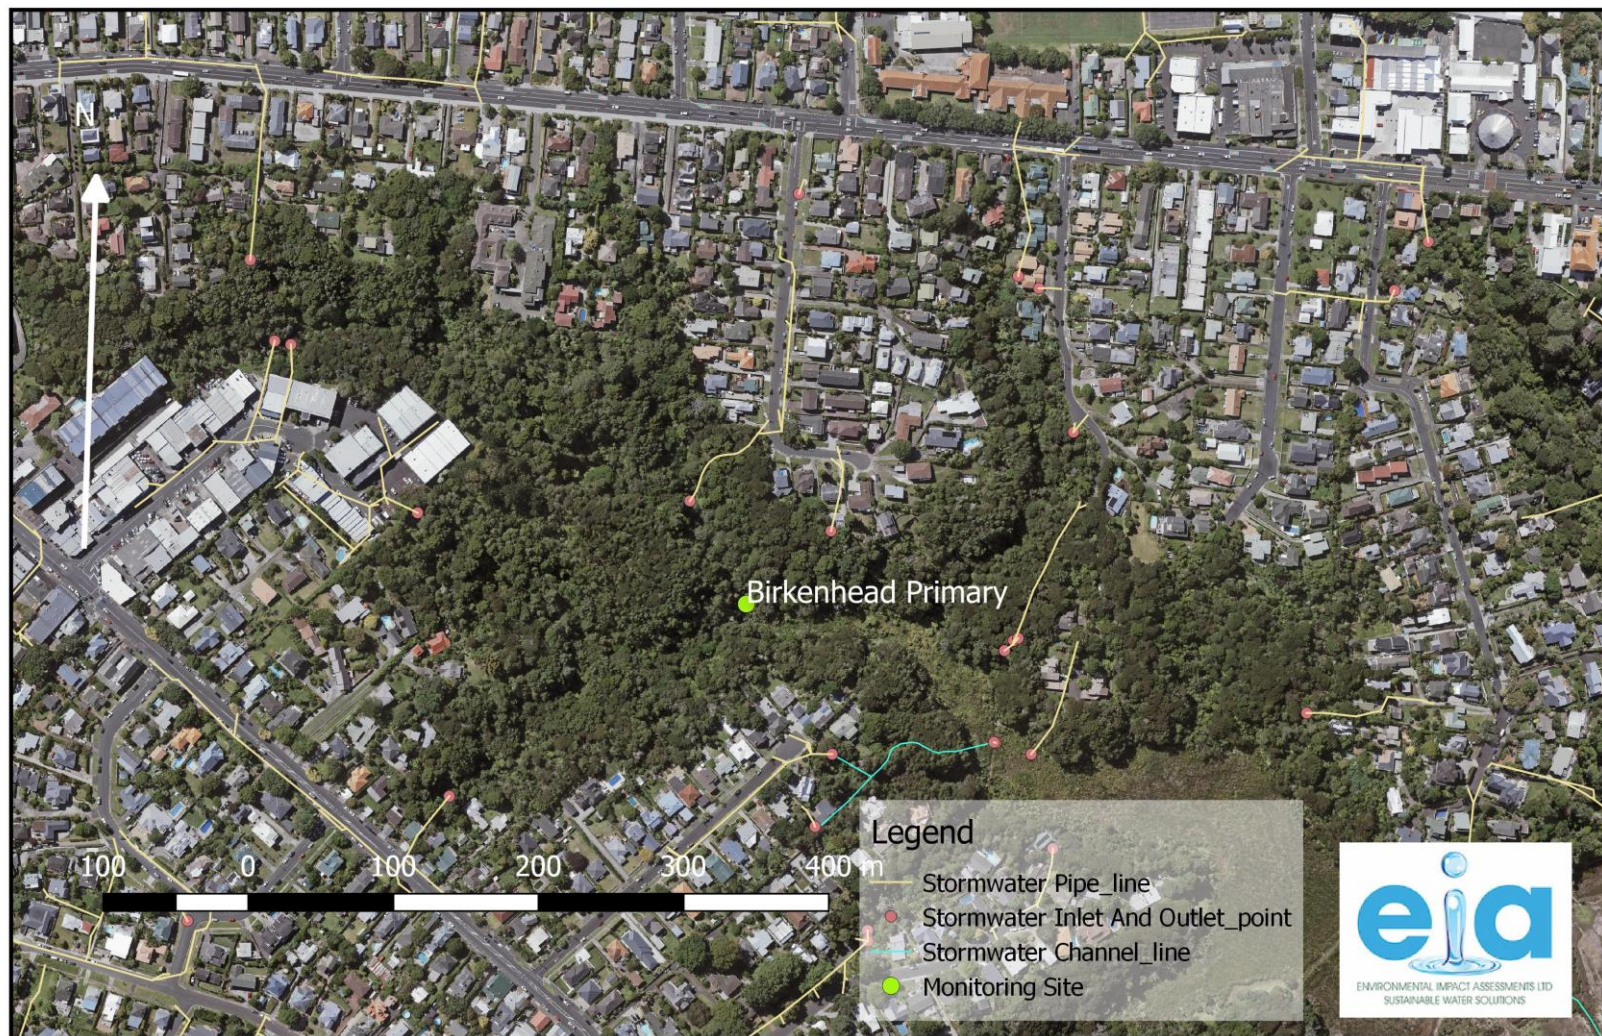
Map 4: Waimanawa Creek Catchment

The New Zealand Freshwater Fish Database reveals 9 fish monitoring records for this creek since 1998. School stream care monitoring has revealed 3 fish species have previously been captured including longfin eels, shortfin eels and banded kokopu. The Wai Care Database reveals that the aquatic invertebrate fauna comprises flatworms, wood cased caddisflies, dragonflies, damselflies, oligochaete worms, pond skaters, amphipods, snails, backswimmers, leeches, midge fly larvae, free swimming mayflies, amphipods, isopods, mites, and semi aquatic spiders. A composite analysis of all invertebrates captured during school stream care visits reveals an SBMCI value of 94 indicative of moderate pollution. This creek becomes very small during the summer often displayed by a series of stagnant pools in the lower reaches. A map of the Waimanawa Creek is provided overleaf.

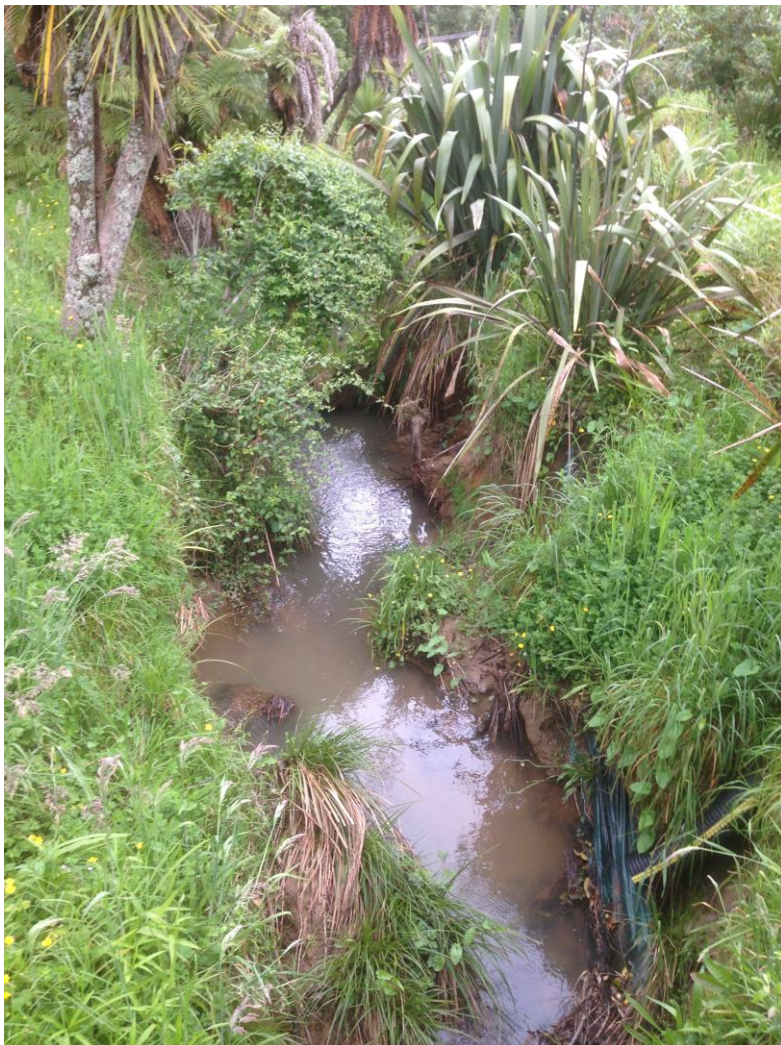
Photo 5: Castleton Creek Monitoring Site

Castleton Creek is a 3rd order tributary that has a catchment area of 1.6 km² and is located 1.34 km from sea when measured at the Verran Primary School stream care monitoring site. The stream falls within a scenic reserve (Ridgewood Reserve) and residential housing bounded by Eskdale Rd to the north, Birkenhead Ave to the east and Waipa St to the south. The creek is a tributary of the Oruamo Creek. The riparian margin comprises native broadleaf/podocarp trees with an understory of flaxes grasses and weeds. The creek has many stormwater inputs and the catchment has a total imperviousness of approximately 25.4 % at the Verran Primary School stream care monitoring site. This moderate level of imperviousness is likely to result in relatively poor ecosystem health owing to the highly altered hydrology created by stormwater inputs from impervious land cover. As such this site represents a moderately impacted site for this study.

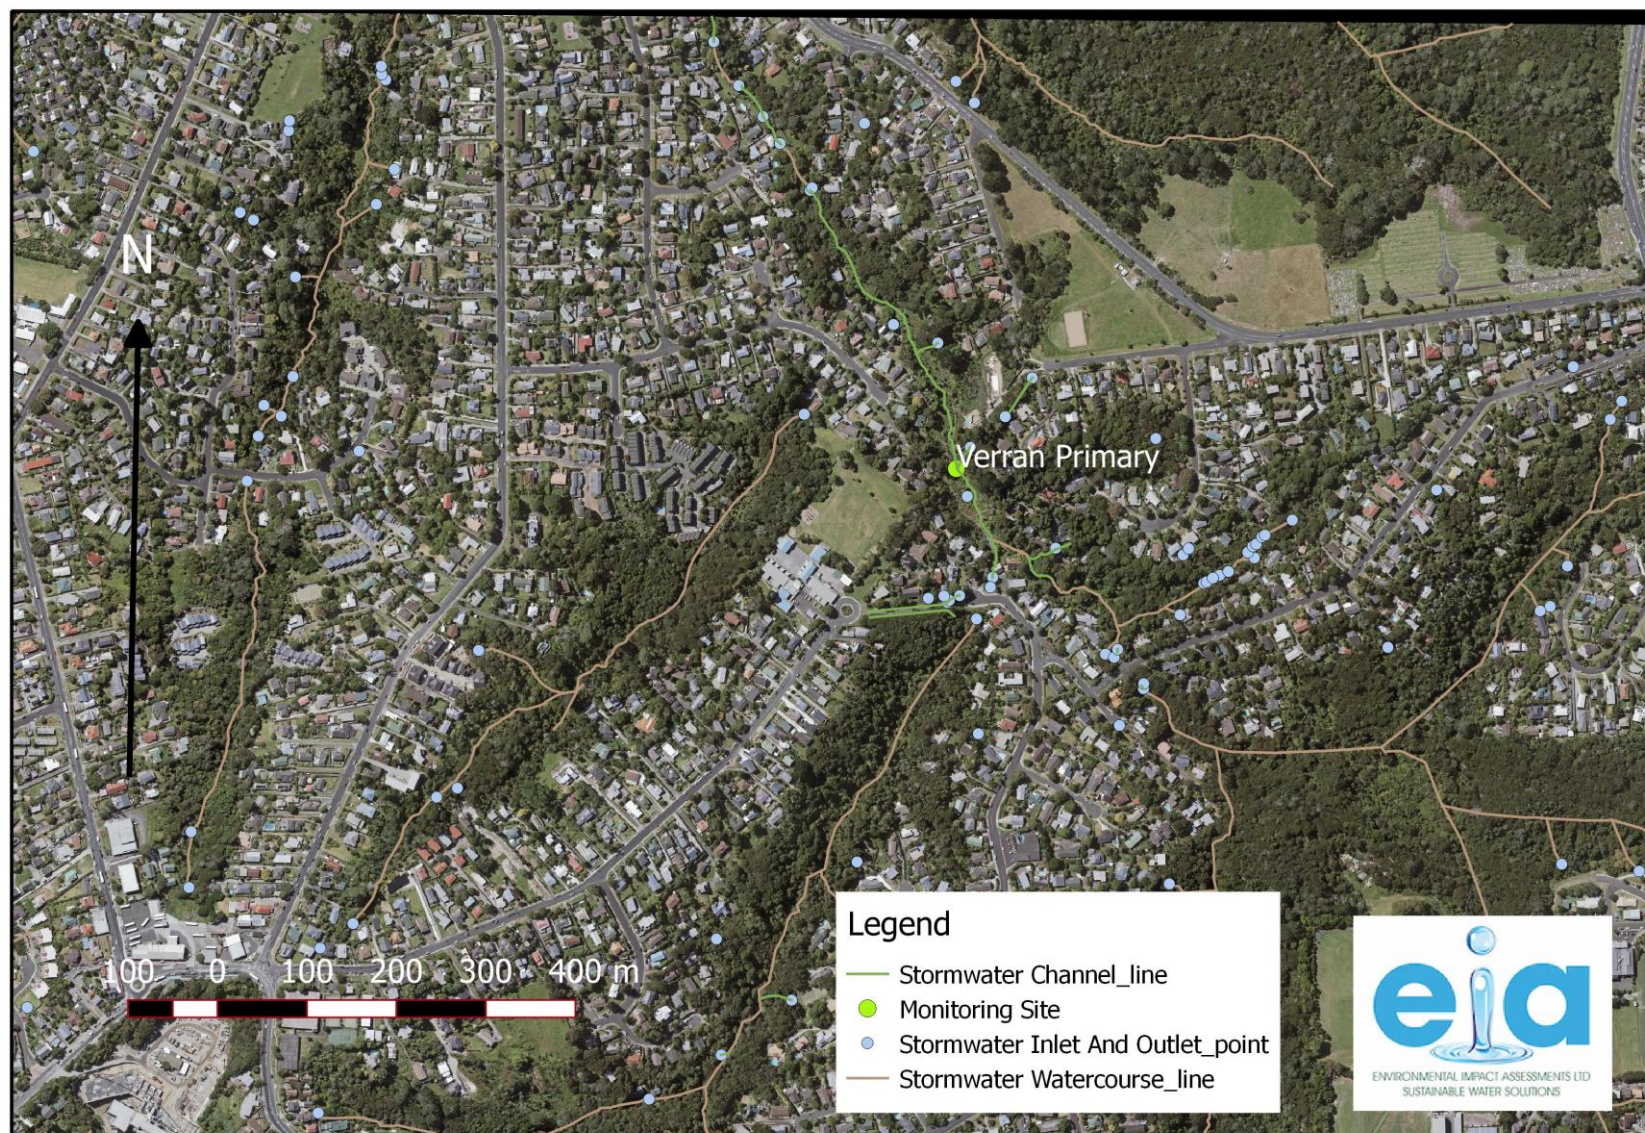
Map 5: Castleton Creek Catchment

midge fly larvae, damselflies and dragonfly larvae. A composite analysis of all school stream care monitoring reveals that this stream has an SBMCI value of 106 reflective of mild levels of pollution. A map of the Castleton Creek is provided overleaf.

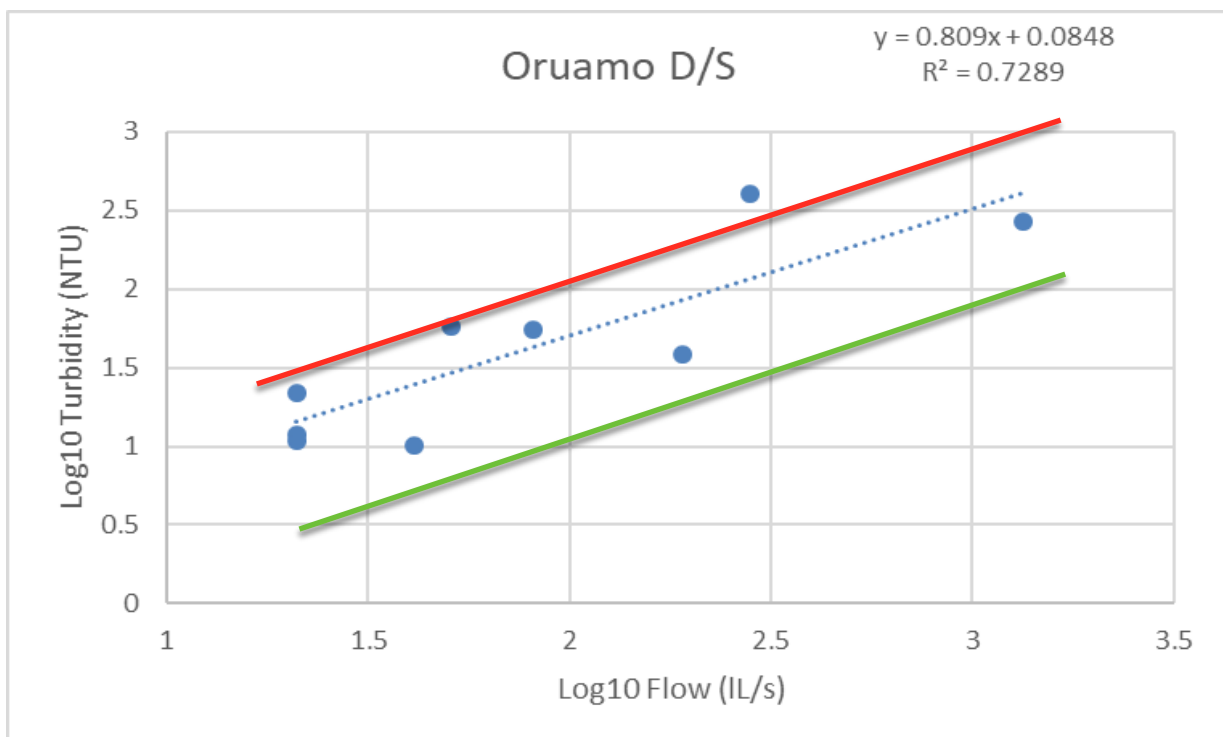
Figure 13: Log 10 Flow / Turbidity Relationship for Oruamo D/S

discharged into the stream and stream sediments are mobilized creating silty water. The regression model is good explaining 73% of the variability of the data. A future community aspiration goal could be to improve lower turbidity of the creek (green line) conversely if catchment management practices were negligent then turbidity would increase (red line).

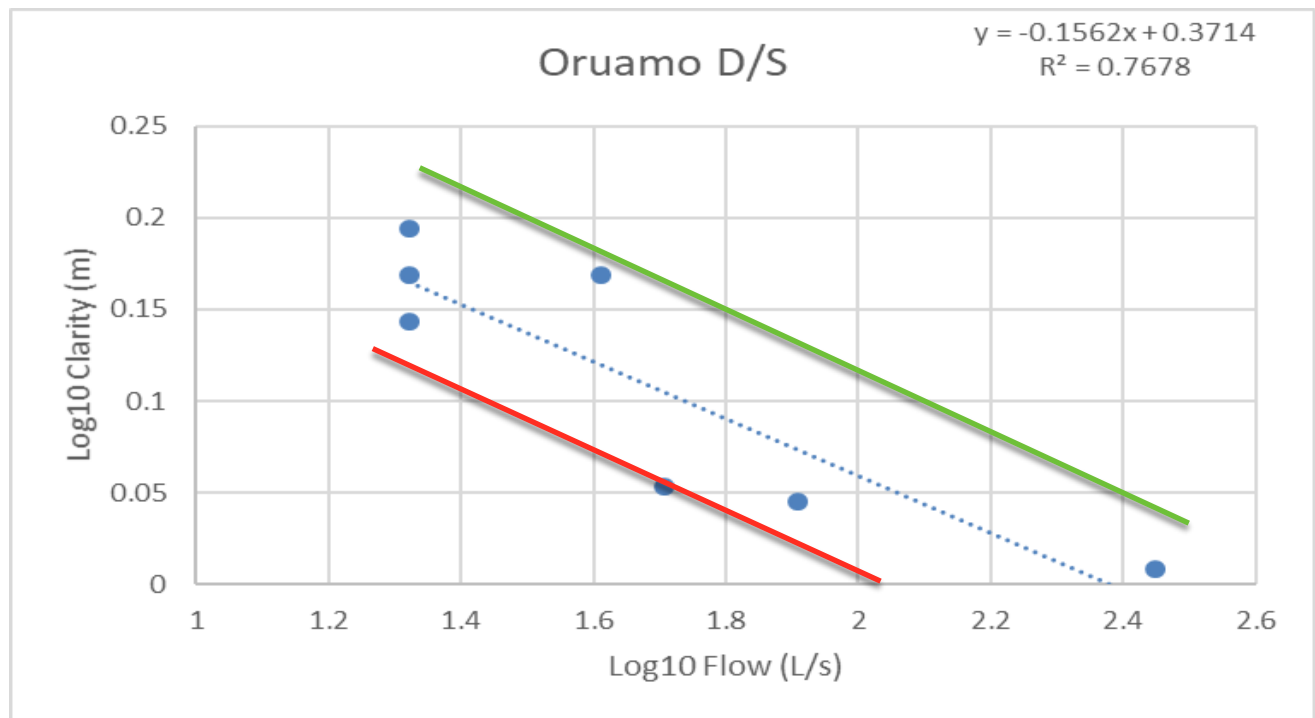
Figure 14: Log 10 Flow / Clarity Relationship for Oruamo D/S

Figure 14 shows the flow / clarity relationship for Oruamo D/S. there is some scatter around the line of best fit however the model is still good for predicting values. As flow increases, water clarity decreases. This is an expected trend as silty stormwater enters a stream and increased flows mobilise stream sediments. A future community aspirational goal could be to improve water clarity of the creek (green line) conversely if catchment land management practices were negligent then water clarity for a given flow would decline (red line).

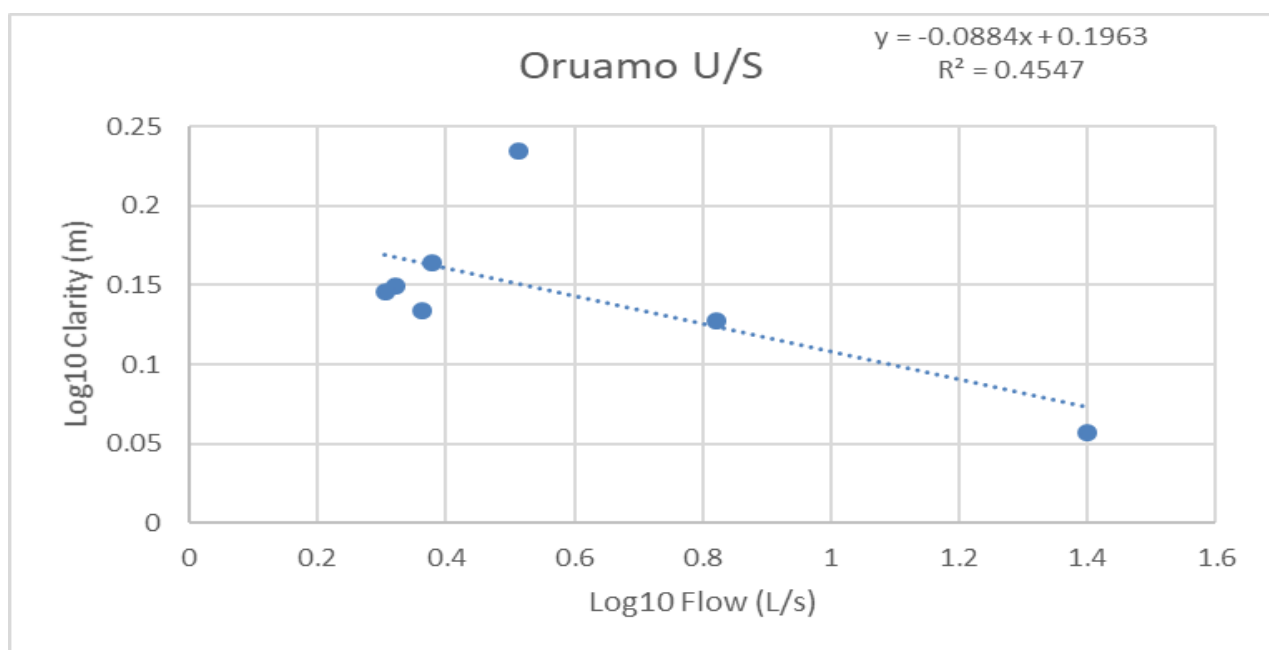
Figure 16: log10 Flow / Clarity Relationship at Oruamo U/S

Figure 16 shows the flow / clarity relationship at Oruamo U/S. There is a lot of scatter around the line of best fit and the model is unreliable at predicting values ($R^2 = 0.45$). Water clarity declines at increasing flows which is an expected trend.

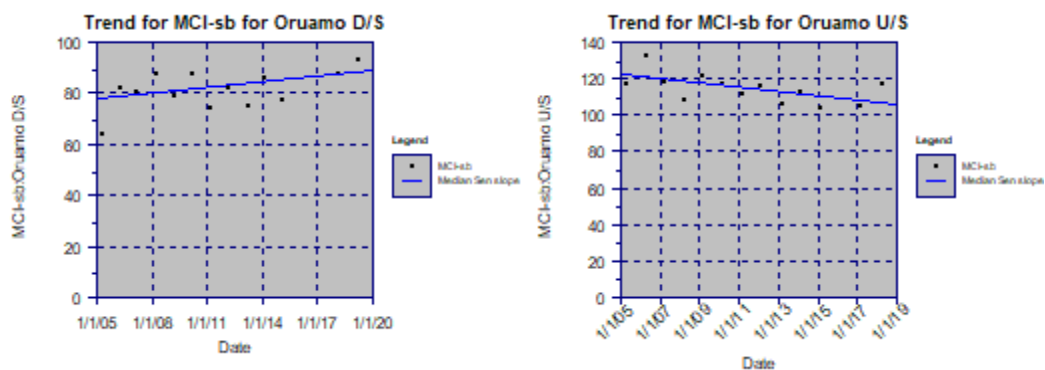
Figure 23: Time Series Analysis of Oruamo Creek Sites

Two Oruamo Creek sites have been monitored by Auckland Council since 2005. The following plots show time series analysis of how SBMCI values have tracked since this time.

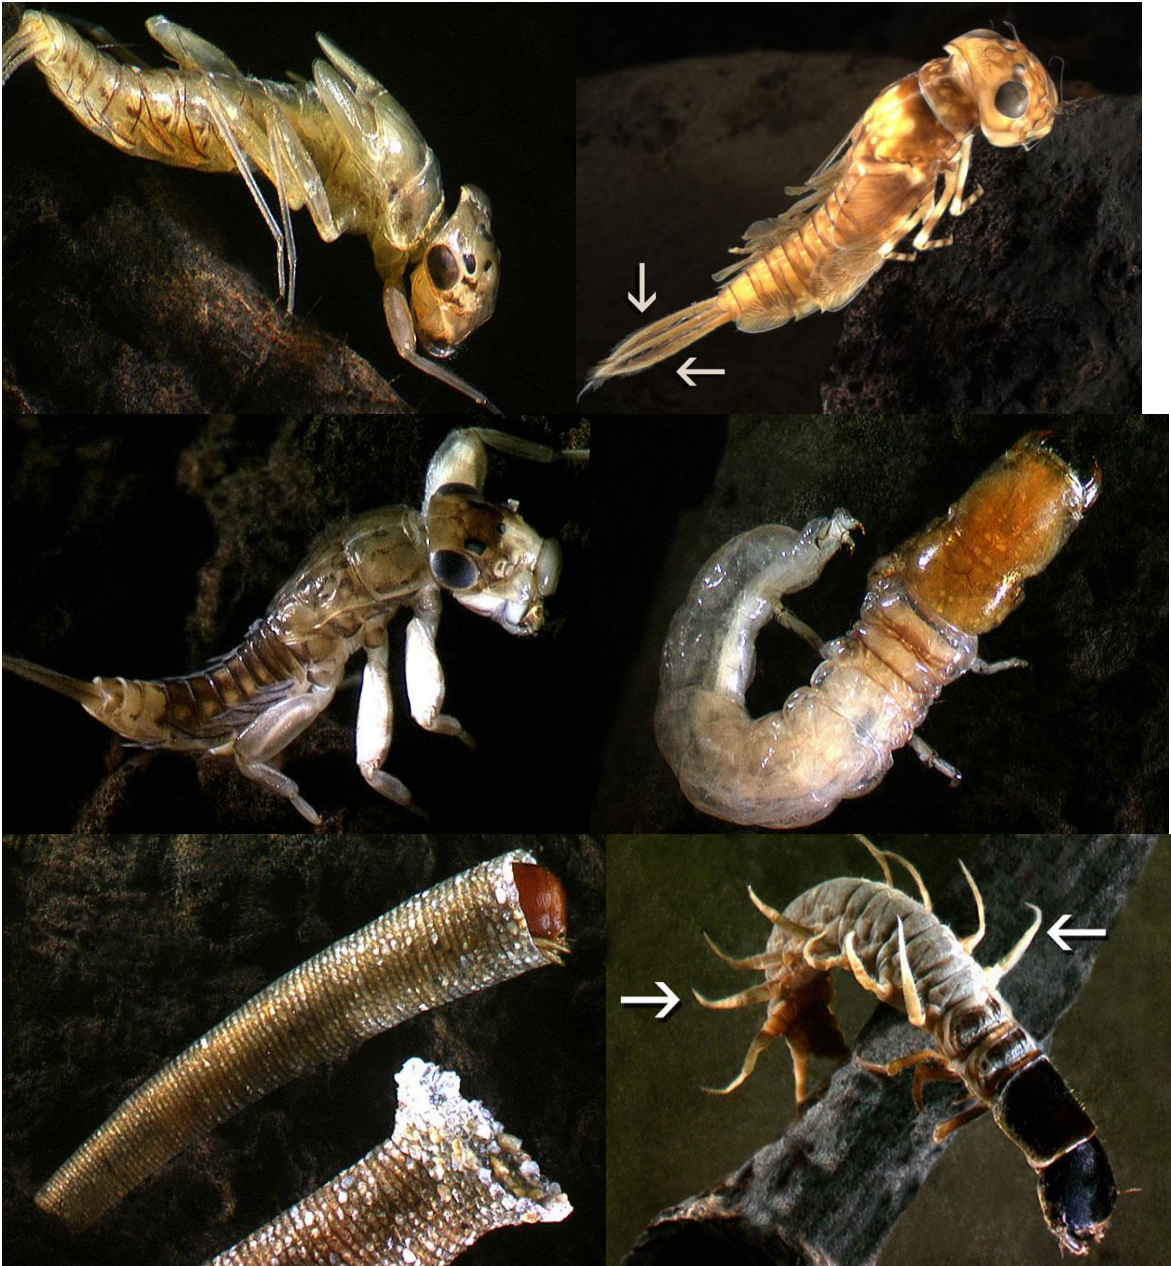
Photo 6: Sensitive macroinvertebrates unique to Oruamo U/S site. Photos taken from the Landcare Research Identification Guide.

Photo 6 shows the sensitive macroinvertebrates unique to the Oruamo U/S site. The three mayflies (Arachnocolus top left, Ameletopsis top right and Austroclima mid left) are particularly sensitive to pollution and have tolerance scores of 10,8.1 and 6.5 respectively. They require a thin film of periphyton (algae) to graze upon with cool clear water as sediment laden water can irritate their gills. Typically, these species are found in bush covered catchments with well oxygenated cool water with a gravel base to the stream. Ameletopsis is a predator feeding off other macroinvertebrates

The uncased caddisfly *Edpercivalia* (mid right) is also a predator feeding off other macroinvertebrates and has a tolerance score of 6.3. The cased caddisfly *Pycnocentria* (bottom left) is also commonly found in bush covered catchments with cool clear water and has a tolerance score of 6.8. They are collector gatherers feeding on a variety of periphyton and detritus. The Dobson fly *Edpercivalia* (bottom right) is also common in bush covered catchments with cool clear water. They are also predators feeding off other macroinvertebrates and have a tolerance score of 7.3.

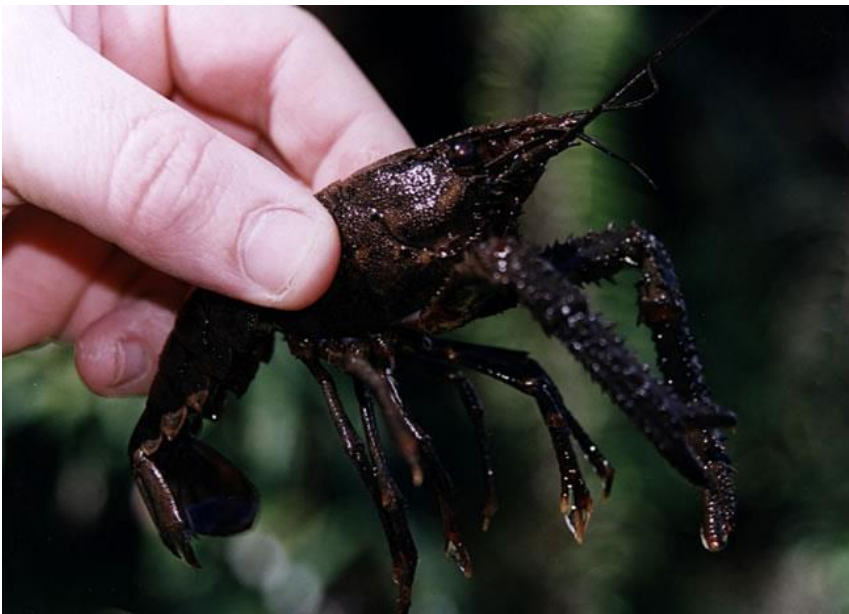
Photo 7: The Koura

The koura (*Paranephrops planifrons*) is unique to the Oruamo creek (U/S and D/S) and Kahika creek. This species of invertebrate is often referred to as a keystone species because it feeds off biofilms growing on wood. In doing so it breaks down organic matter to a size that other animals and bacteria can feed off. Any decline in koura could result in a decline of other species of macroinvertebrates. Koura are also culturally significant to Maori as a mahinga kai species that is taonga. The Koura has a pollution tolerance value of 8.4 meaning it is particularly sensitive to pollutants in water. Its' presence in the Kahika Creek is surprising as this creek is moderately polluted.

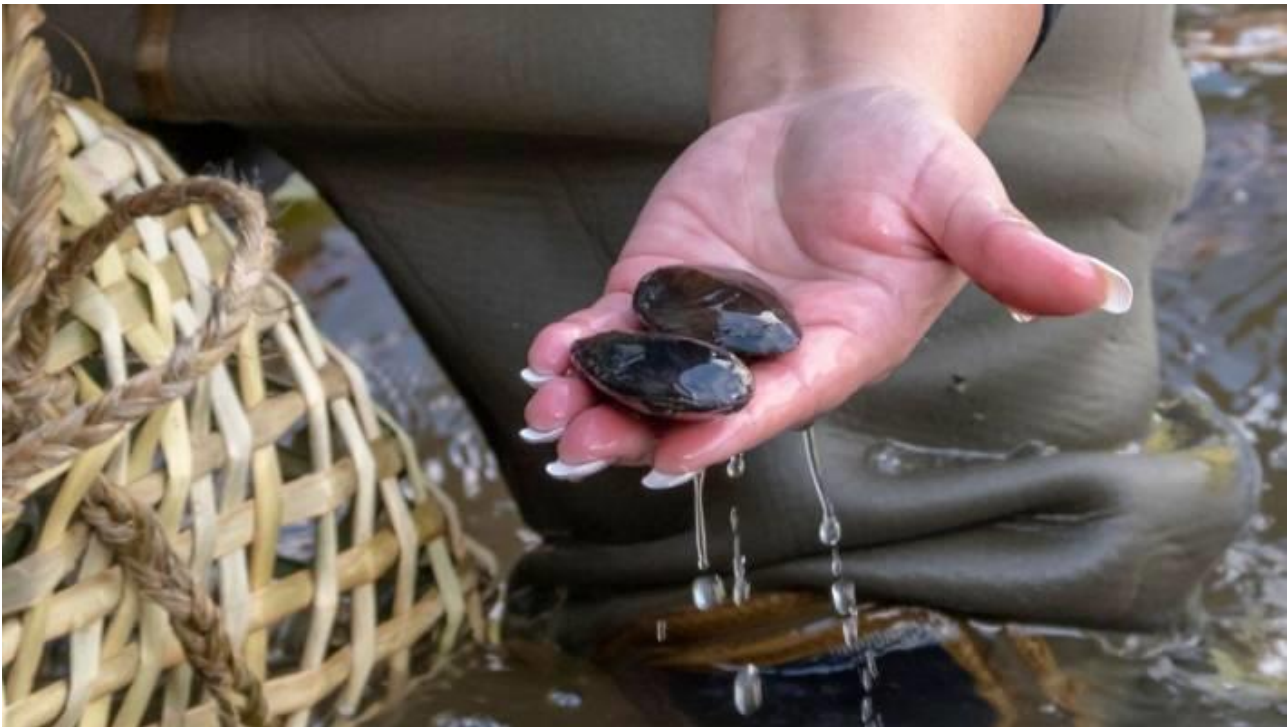
Photo 8: Freshwater Mussel – Kākahi taken from NZ stuff website

Kākahi (freshwater mussels) are common and widespread throughout New Zealand, in habitats ranging from small, fast-flowing streams to lakes. Kākahi are unique to the Oruamo D/S site and were recently discovered by Neil Henderson during some volunteer monitoring of the creek. Kākahi are also of cultural significance to Maori as a mahinga kai species. This species of Kākahi (*Hyridella menziesii*) has a pollution tolerance value of 6.7 being relatively sensitive to pollution in streams.

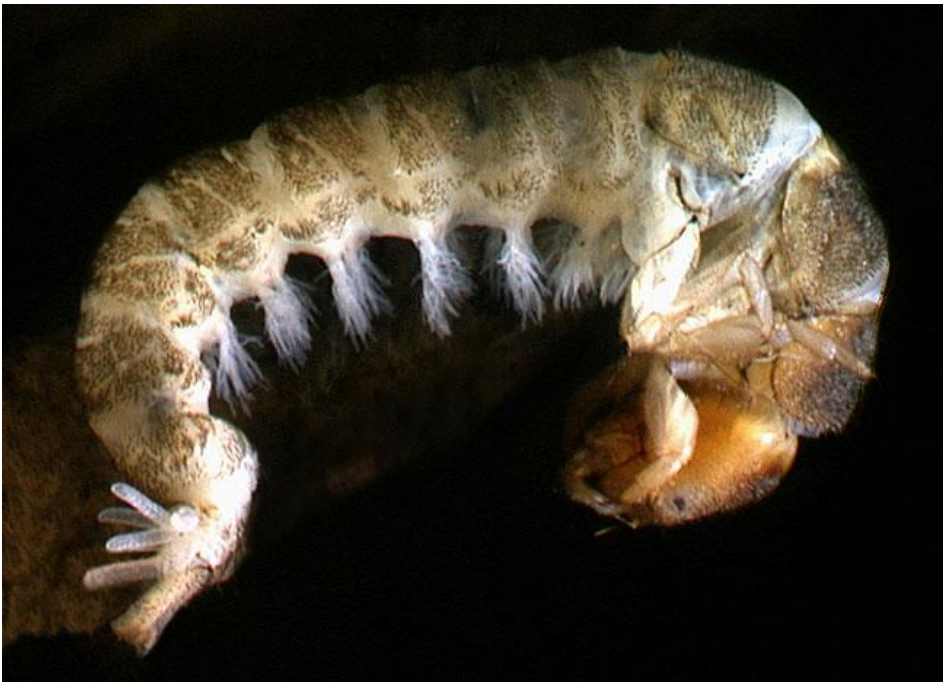
Photo 9: *Orthopsyche* Caddisfly

The caddisfly *Othropsyche* is an omnivore feeding on any detritus or other invertebrates that it captures by making an underwater web. These caddisflies are characteristically in cool clear bush covered catchments. They are unique to the Oruamo U/S and Kahika creek sites. The *Orthopsyche* caddisfly has a pollution tolerance value of 7.5 so their presence in the Kahika creek is surprising as this creek is moderately polluted.
