Community Science Stream Health Monitoring Programme

Results Summary For Kaipātiki Project

ENVIRONMENTAL IMPACT ASSESSMENTS CLIENT REPORT KP 2019-1
SEPTEMBER 2019

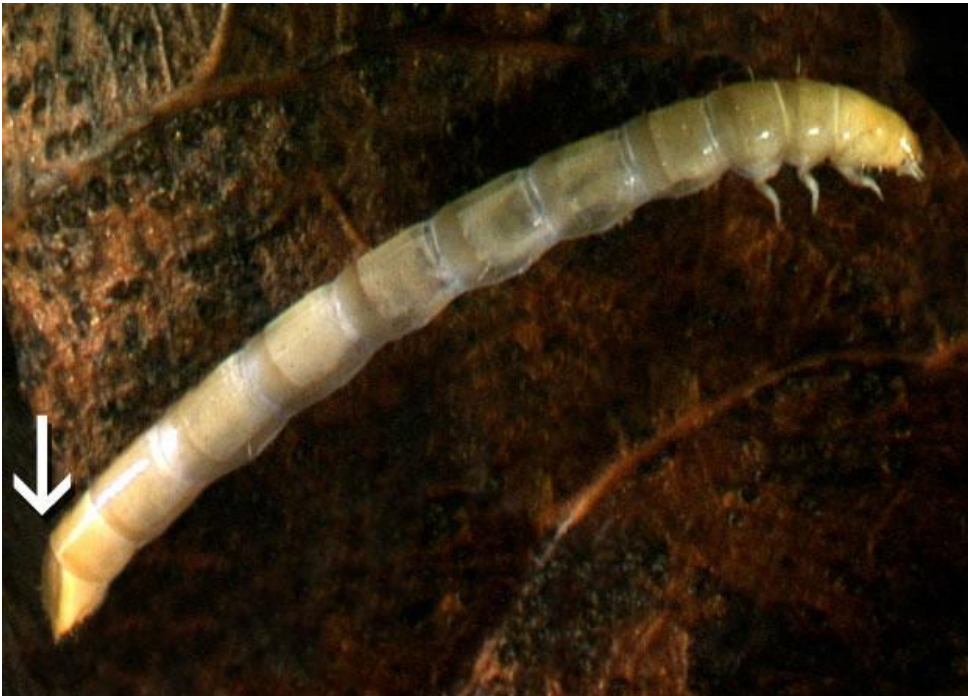
Photo 10: The *Ptilodactylidae* Beetle

The Ptilodactylidae beetle is unique to the Oruamo U/S and Waimanawa Creek sites. These beetles are common in bush covered catchments with cool clean water. They have a pollution tolerance value of 7.1 meaning they are quite sensitive to pollution.

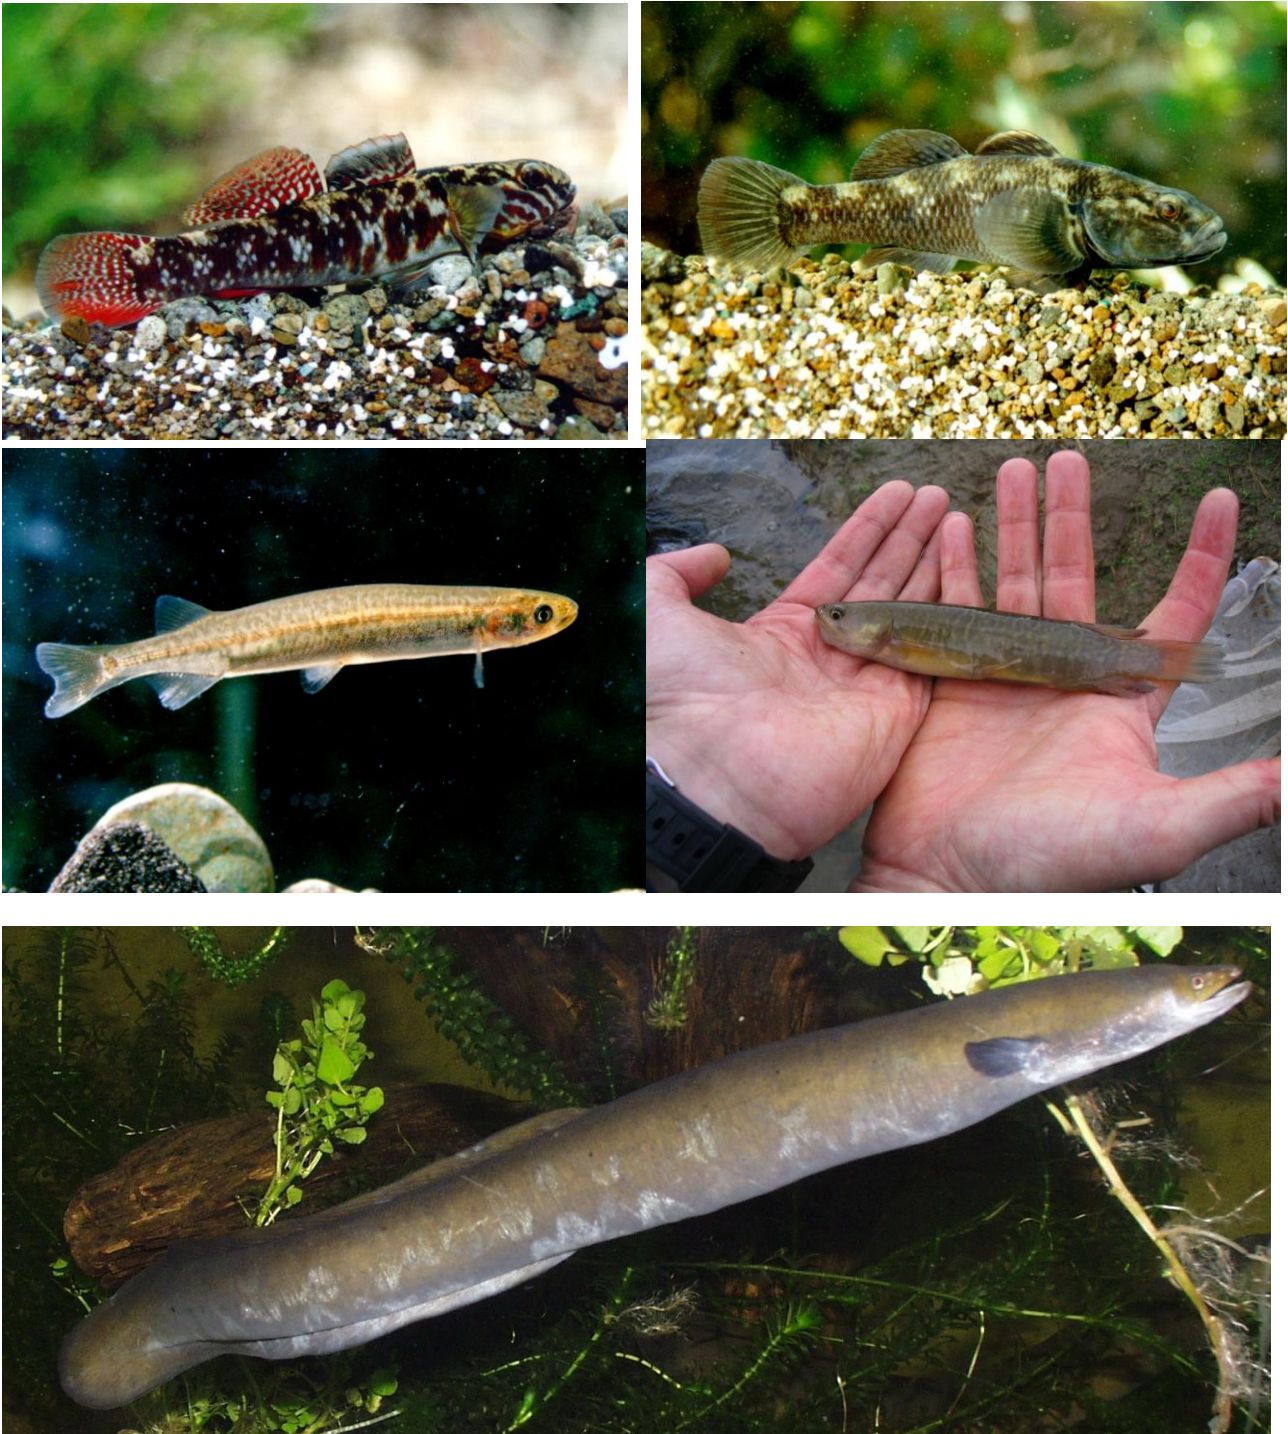
Photo 11: Native fish captured during school stream care surveys

Photo 11 shows some of the native fish captured during Kaipātiki school stream care surveys. The red markings of the redfin bully (top left) is prominent in the male fish, another bully commonly found in Auckland Streams is the common bully (top right). Inanga (mid left) are common in the lower reaches of the Oruamo Waimanawa and Kahika Creeks. Banded kokopu (mid right) are common at all sites. Shortfin eels (bottom) are common in the lower reaches of most creeks in New Zealand and have been recorded in the Waimanawa and Oruamo Creeks.

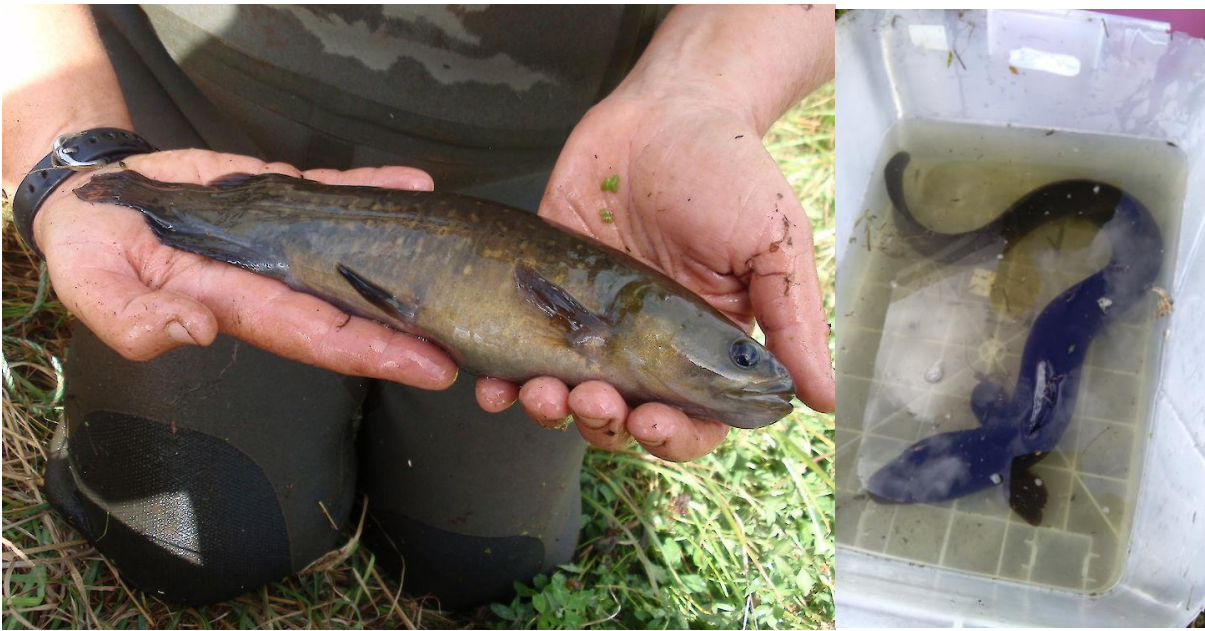
Photo 12: Giant kokopu (left) photo taken by Helen McCaughan DOC, longfin eel (right) photo taken by EIA Ltd.

Photo 12 shows the giant kokopu and longfin eel. Many of the eels found in our awa are of a good size, occasionally exceeding 1m in length. This indicates a healthy fishery with a good supply of adults to ensure continued sustainability of the fishery.
